Quality Assurance and Source Inspection

Contract #: 04-0120F4Cty: SF/ALA Rte: 80 PM: 13.2/13.9File #: 13.28**WELDING INSPECTION REPORT****Resident Engineer:**Pursell, Gary**Address:** 333 Burma Road**City:** Oakland, CA 94607**Report No:** WIR-007756**Date Inspected:** 15-Jul-2009**Project Name:** SAS Superstructure**OSM Arrival Time:** 700**Prime Contractor:** American Bridge/Fluor Enterprises, a JV**OSM Departure Time:** 1530**Contractor:** Oregon Iron Works Clackamas, Or.**Location:** Clackamas, OR**CWI Name:** Mike Gregson, Jose Salazar**CWI Present:** Yes No**Inspected CWI report:** Yes No N/A**Rod Oven in Use:** Yes No N/A**Electrode to specification:** Yes No N/A**Weld Procedures Followed:** Yes No N/A**Qualified Welders:** Yes No N/A**Verified Joint Fit-up:** Yes No N/A**Approved Drawings:** Yes No N/A**Approved WPS:** Yes No N/A**Delayed / Cancelled:** Yes No N/A**Bridge No:** 34-0006**Component:** Hinge K Pipe Beams**Summary of Items Observed:**

OIW Fabrication Shop-Bay 3**Hinge-K Pipe Beam Assembly 102A-1: 7/15/09**

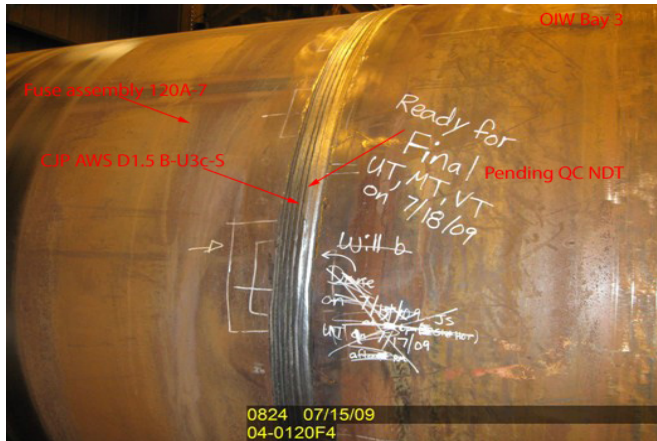
QA Inspector noticed the submerged arc welding (SAW) on CJP (AWS D1.5 B-U3c-S), half fuse pipe assembly, (piece mark identified as a124-5), to half fuse pipe assembly, (piece mark identified as a124-15), had been completed on this date and was sitting idle. QA Inspector noted that 100% final ultrasonic weld inspection would be performed by OIW QC Inspectors on this CJP weld joint after the required 72hrs. cooling time, per AWS D1.5. See attached picture below.
